**AMS Tracker Thermal Control Subsystem**

**TTCB DPS Vibration noise  
test summary**

**AMSTR-NLR-TN-057**

This document describes the work performed on the DPS vibration noise detected during TTCB-S Functional testing at AIDC and checks at SYSU (China).

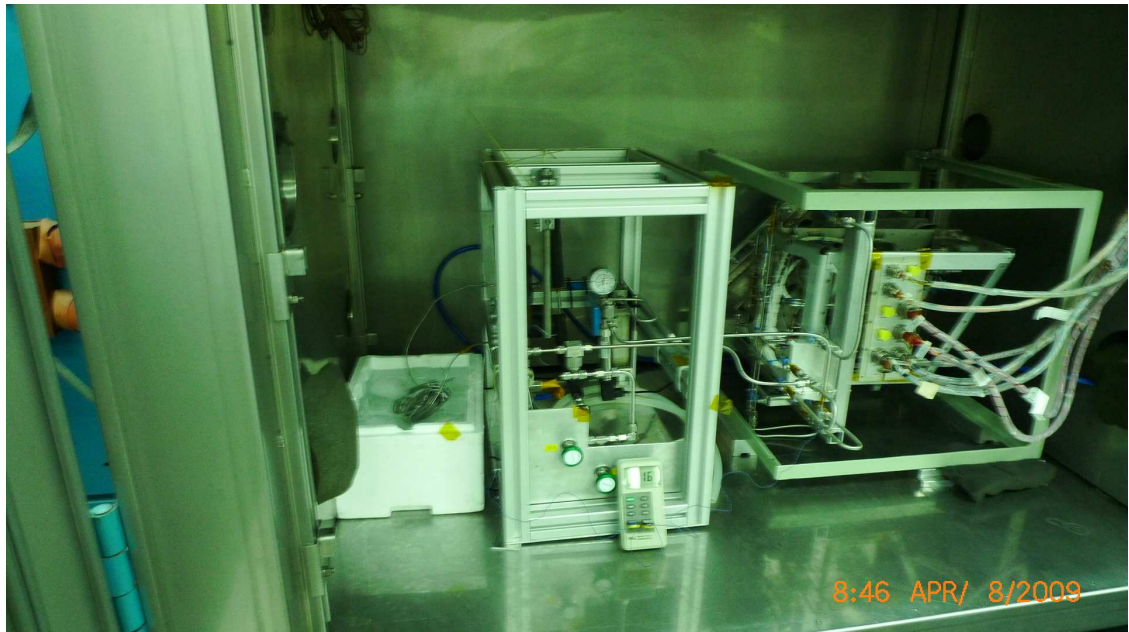
**Figure 3-1: TTCB-S Functional Test set-up**

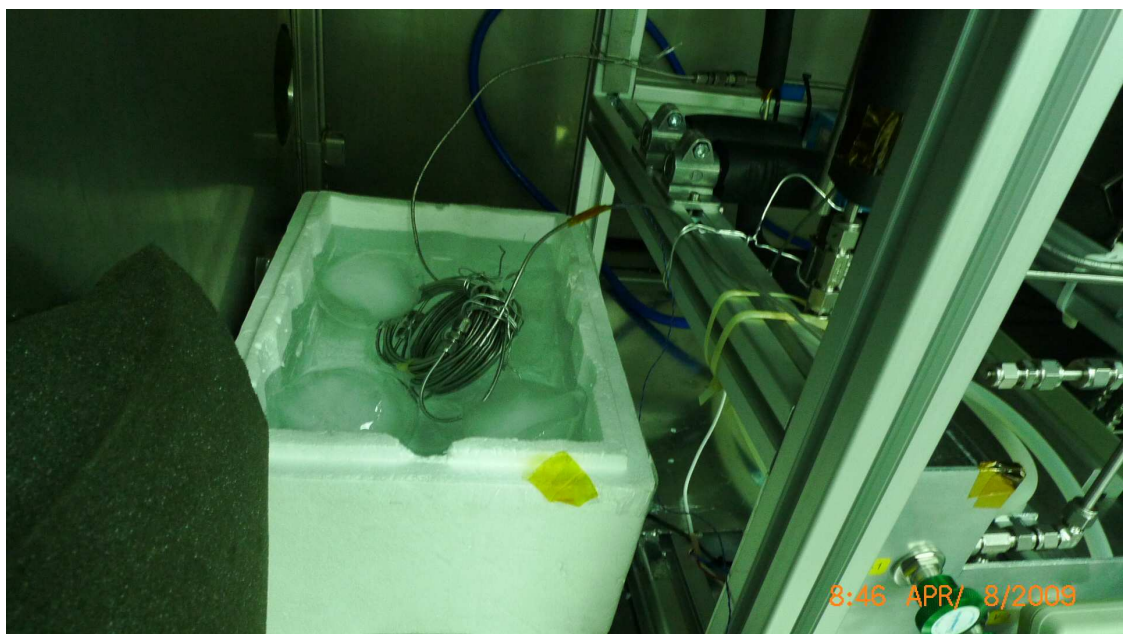
**Figure 3-2: TTCB-S Functional Test set-up detail; coil and upstream TC**

The vibrations were detected mainly on the inlet tubing of the pump. Ranging from the box all the way to the hydraulic resistance coil in the ice bath. This coil simulates the pressure drop of the loop and serves as cooling coil to dissipate the pump heat introduced in the loop.

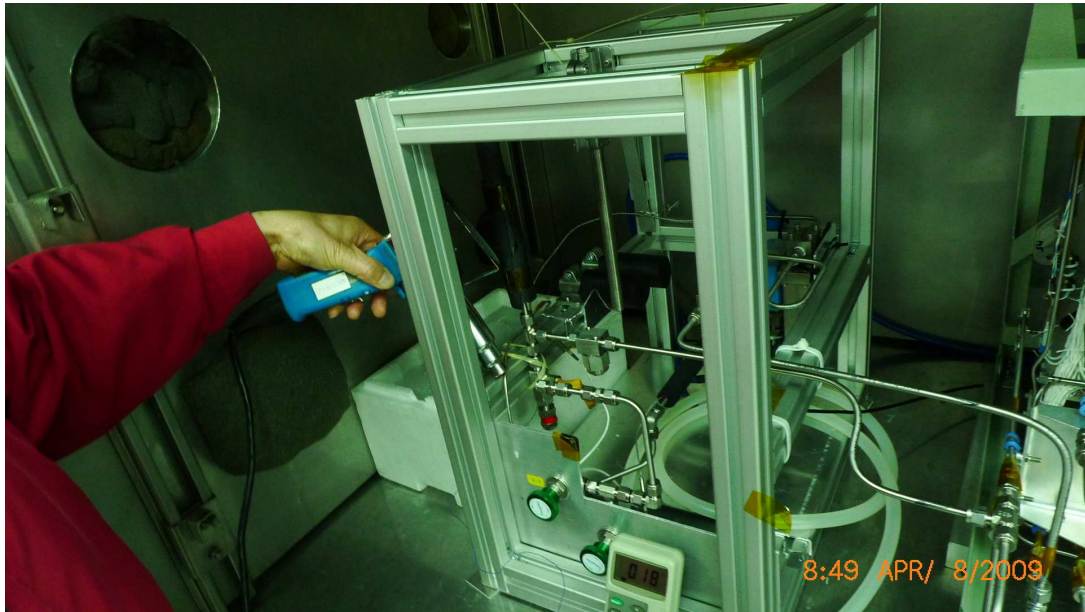
Figure 3-3: TTCB-S Functional Test set-up detail; heating with heat gun

This was performed with the pre-heater section. However no noise reduction was measured. As this vapour section was hydrodynamically far away from the vibration point (Large resistance coil, Flow meter and pump inlet section) a second attempt was done by introducing vapour just prior to the resistance coil. This is described in Appendix G. However also this did not reduce the noise.

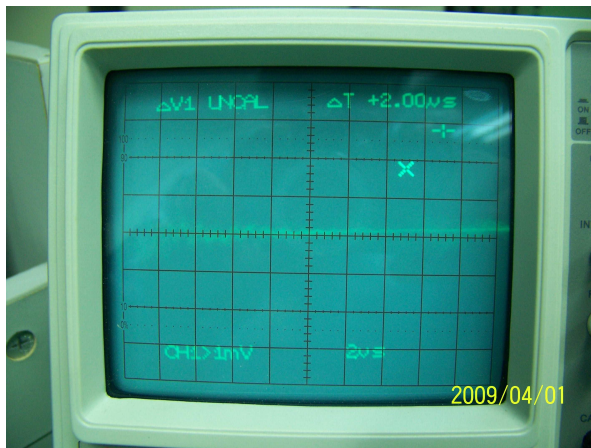
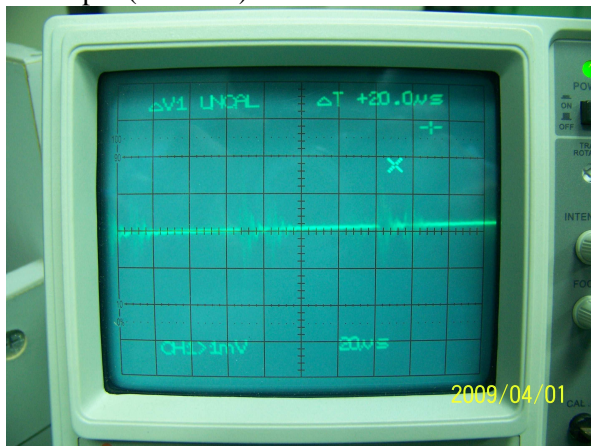
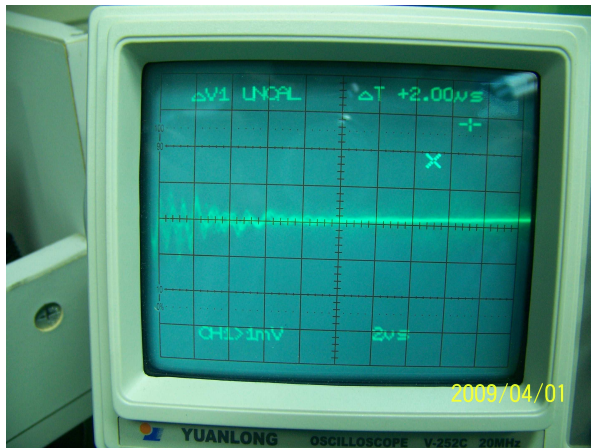
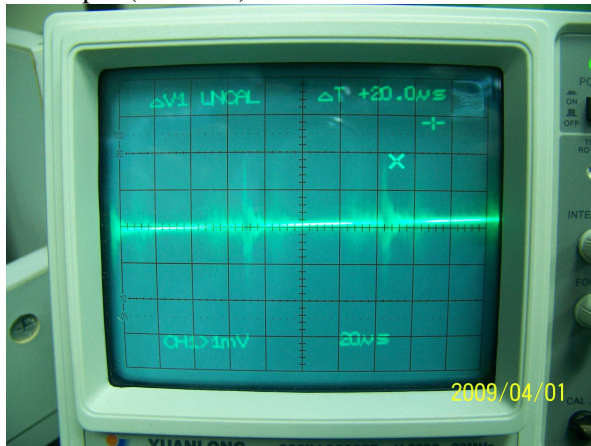
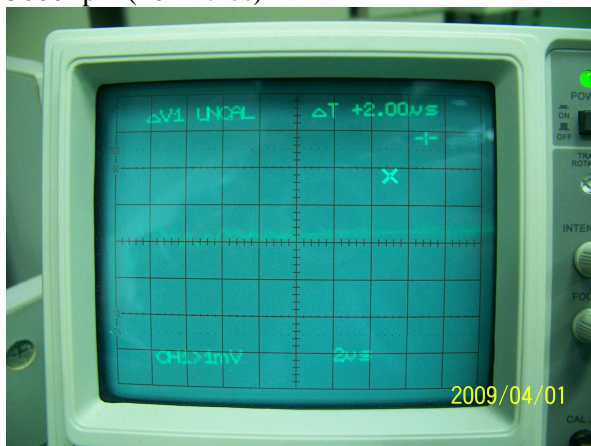
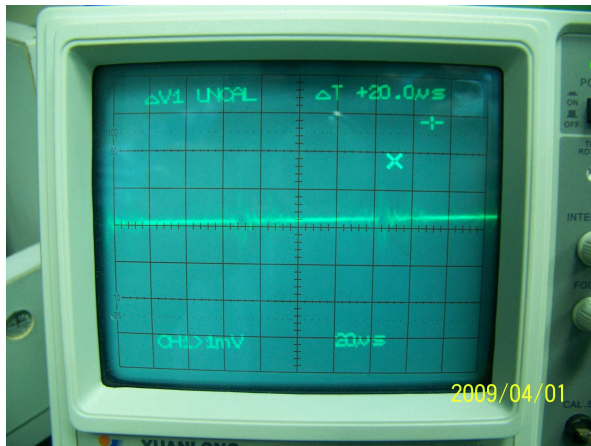
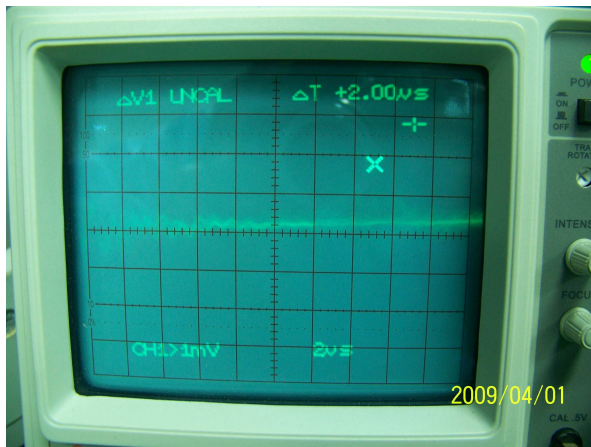
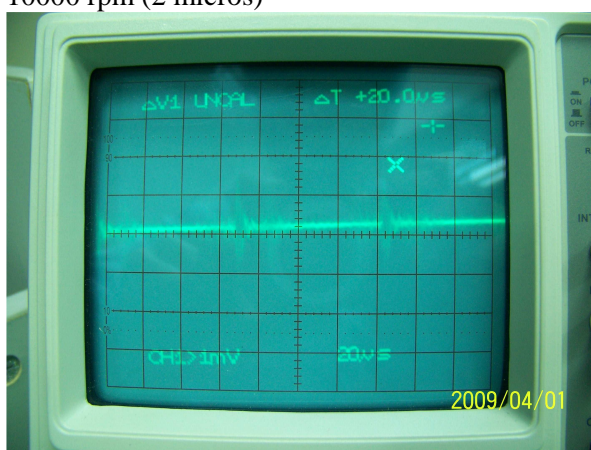
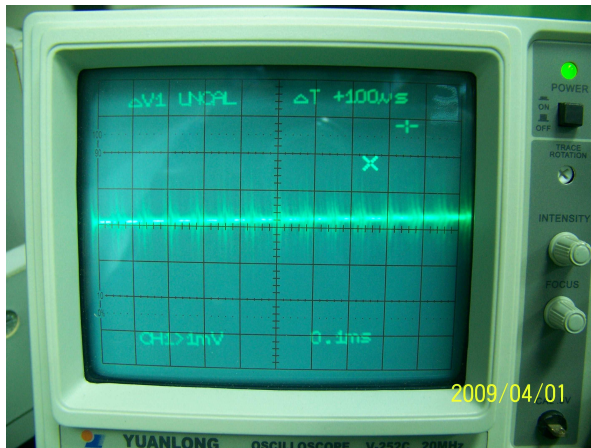
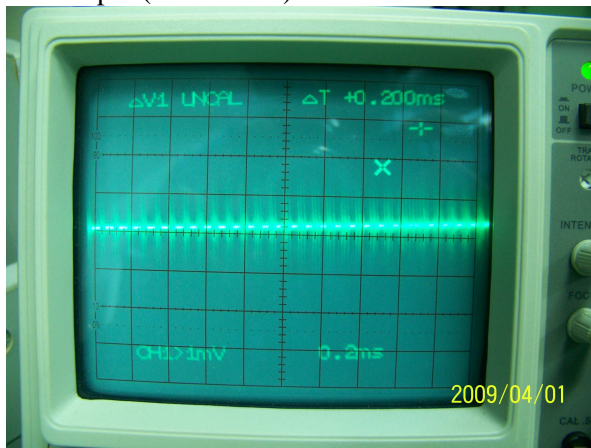
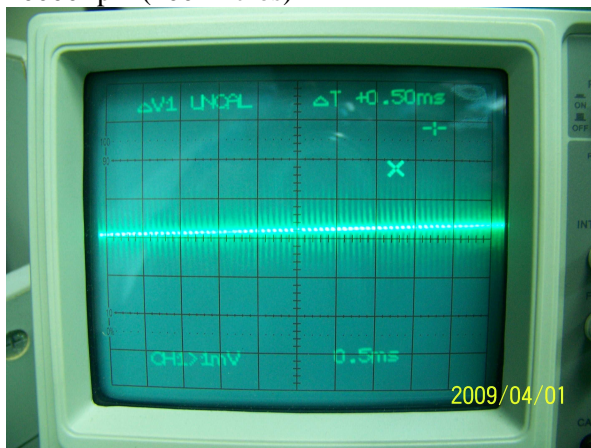
Below you find the photos of the test signals of DPS with different pump speeds, displayed by an oscillograph. The photo name is combined with two parts, e.g. "5000rpm(20 $\mu$ s)". The first part is pump speed and the last part in parentheses is the deltaT of the oscillograph.

The results show that no similar ripple is found with the tests in the final loop lay-out at SYSU. The ripples shown below is only HF-noise and is a factor 100-1000 smaller then the normal DPS-signal.

Results can be found in Appendix D. No noise is detected in the EM-loop at Sun Yat Sen University which is complete similar to the TTCS flight loop. This indicates the induced noise is test loop related and in Flight we will not suffer from these vibrations.

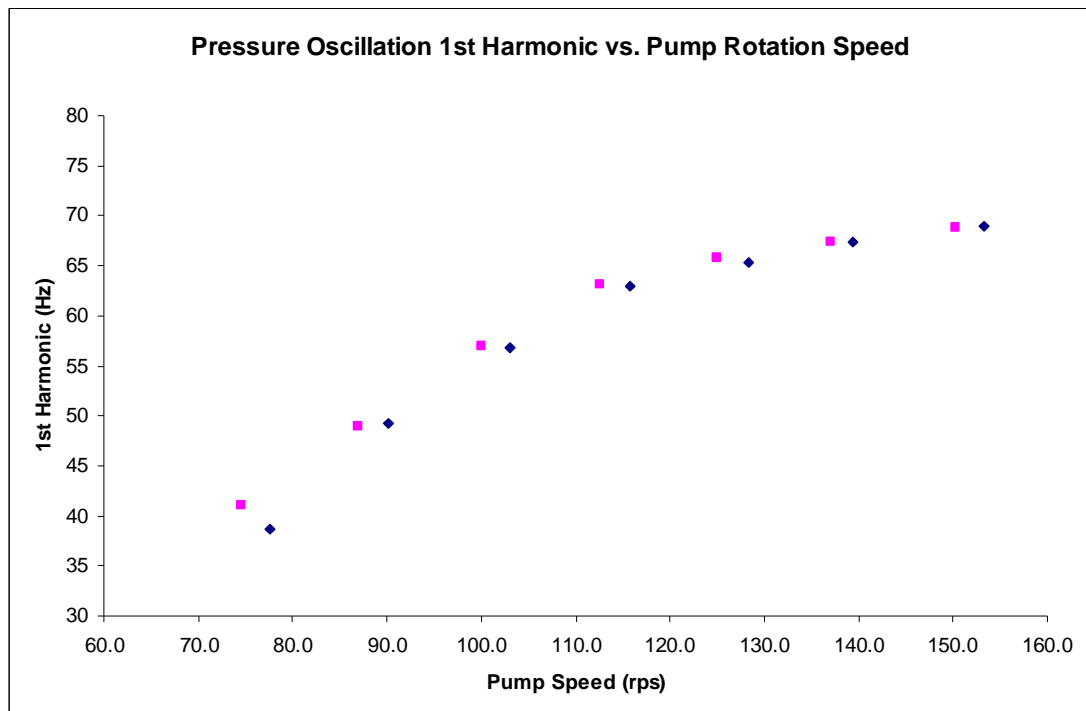
It was found at test setup for TTCB that there is CO<sub>2</sub> pressure oscillation detected by DPS.

Pressure oscillation amplitude exceeds DPS dynamic range (2.5 bar).

Please find in the attachment dependence of pressure oscillation 1st harmonic vs. pump rotation speed.

1st harmonic was measured by HP spectrum analyzer.

There are two sets for set point 22°C and 18°C.

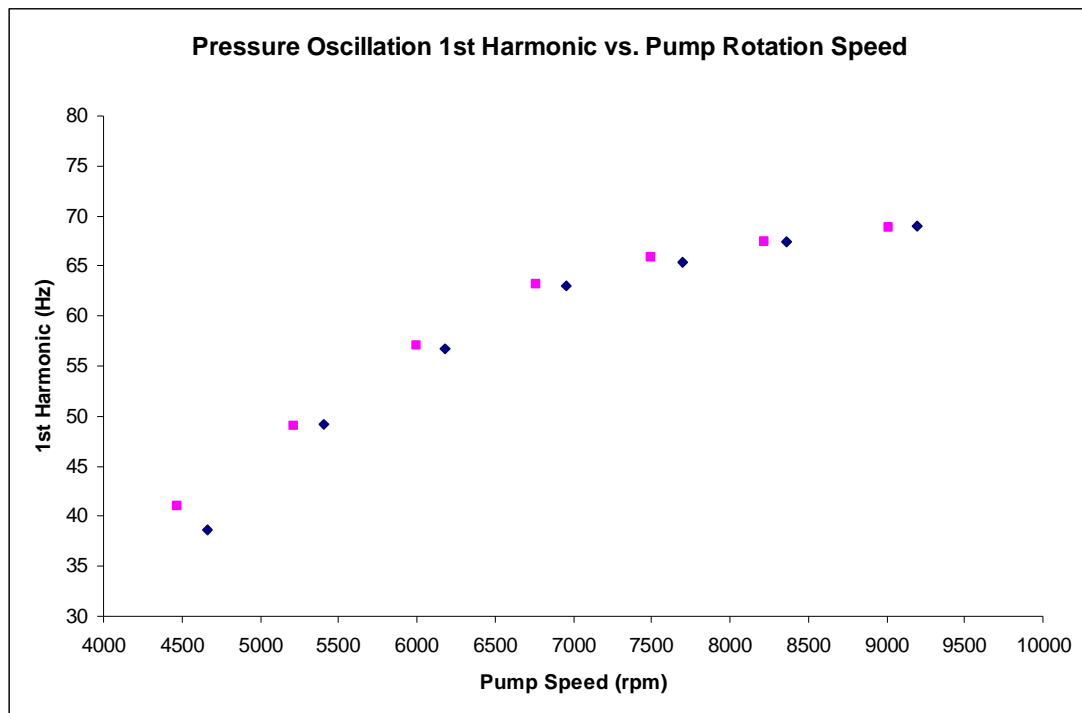
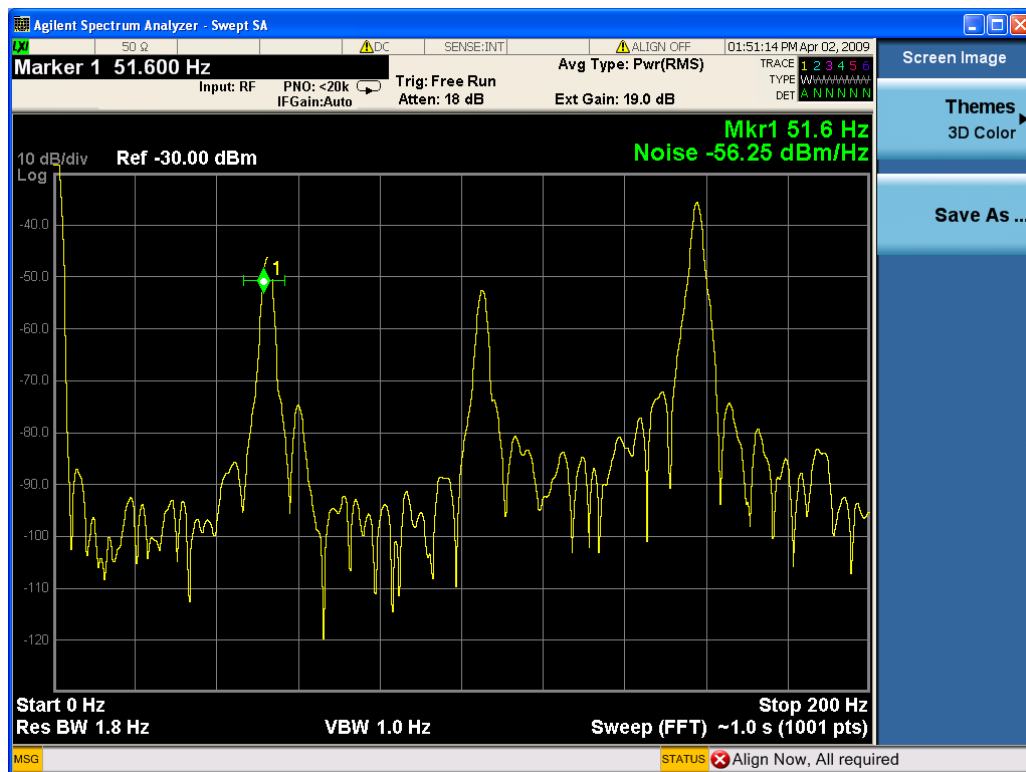
Typical cross correlation DPS noisy signal. In above graphs the first harmonic is shown (indicated with green marker)

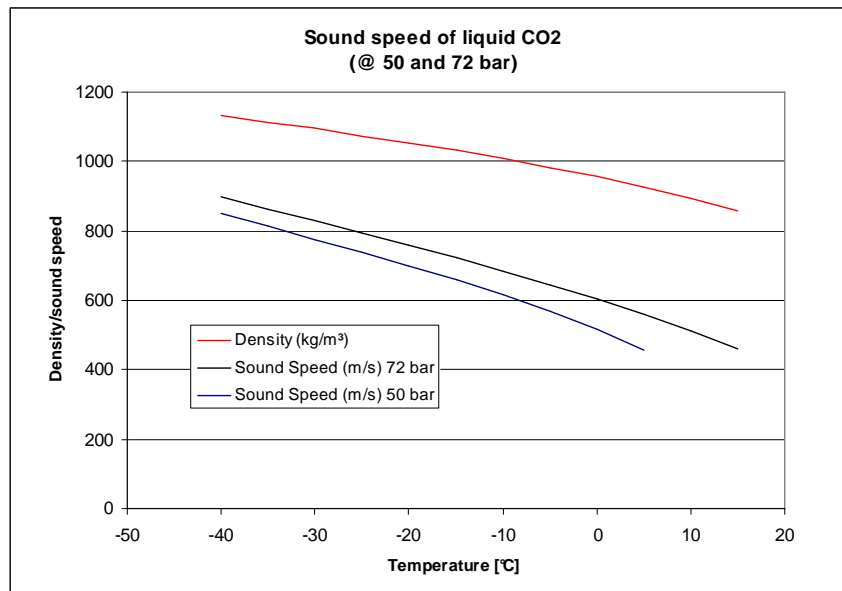
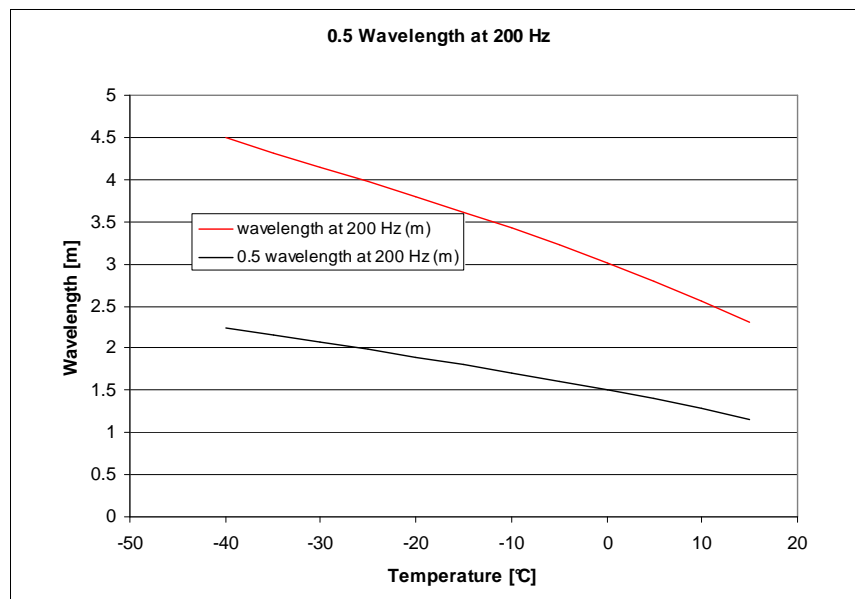
A calculation of the speed of sound has been made as function of temperature. The corresponding half wavelengths at 200 Hz are shown. The values are all above 1 meter. It is therefore unlikely that a sonic wave will be present in the loop as the characteristic loop length of the tubes are a factor 5 or more lower than 1 meter. For lower frequencies (e.g. 65 Hz) the wavelength will even further increase (3.6 m half wavelength).

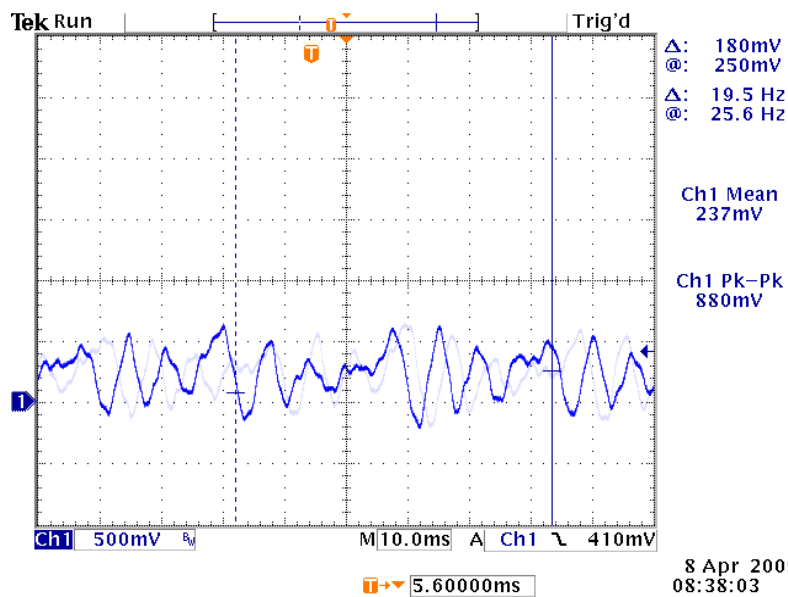
Liquid flow 4000 rpm

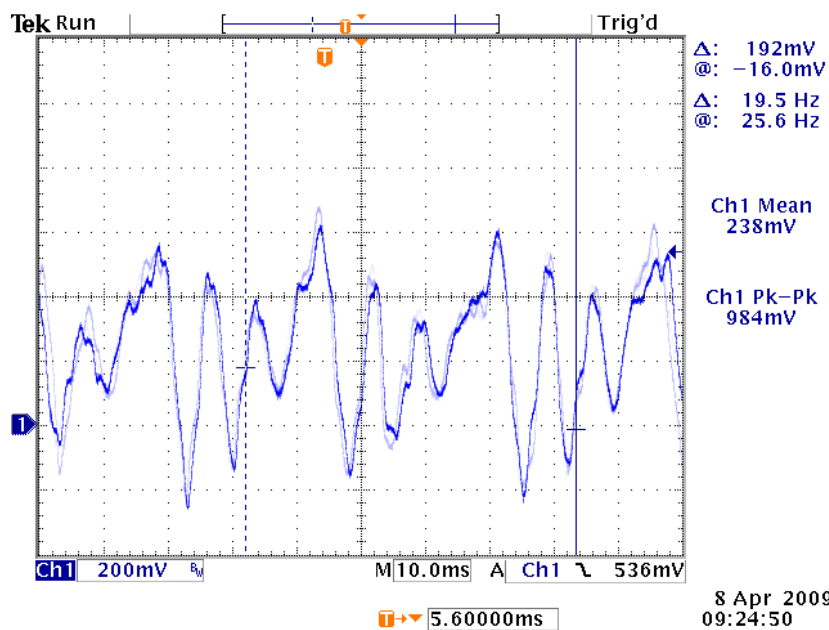
Two-phase upstream coil 4000 rpm

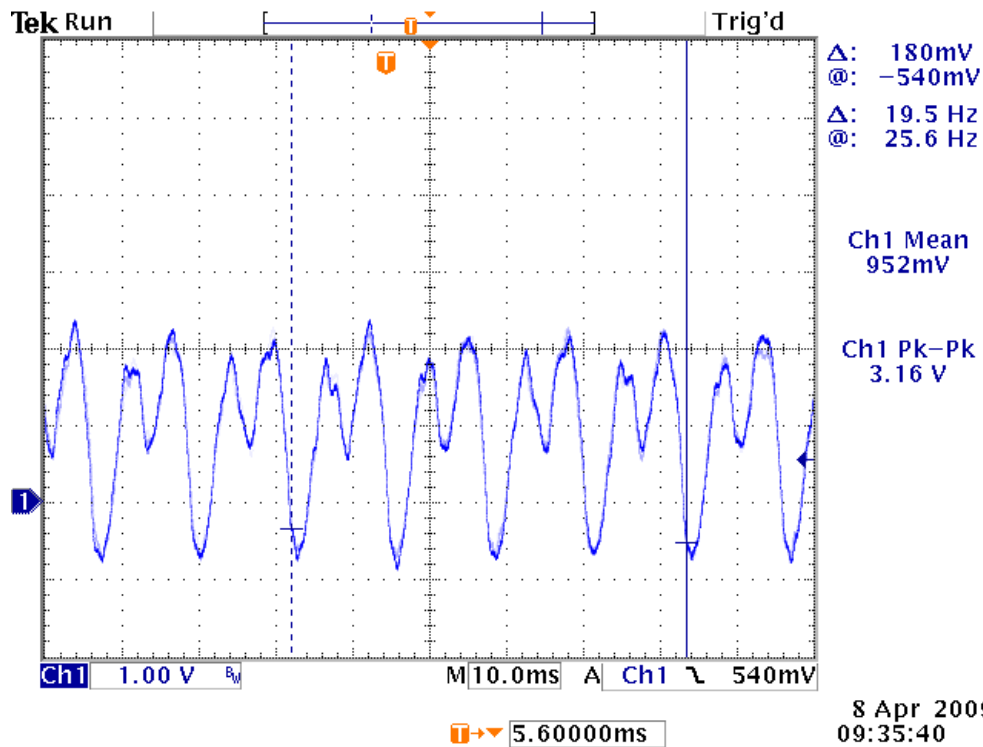
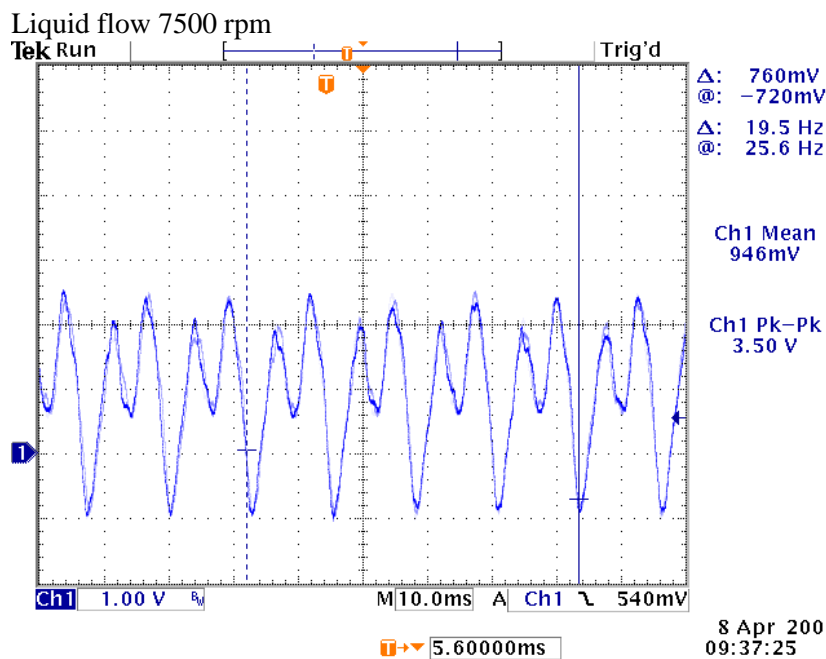
Two-phase upstream coil 7500 rpm

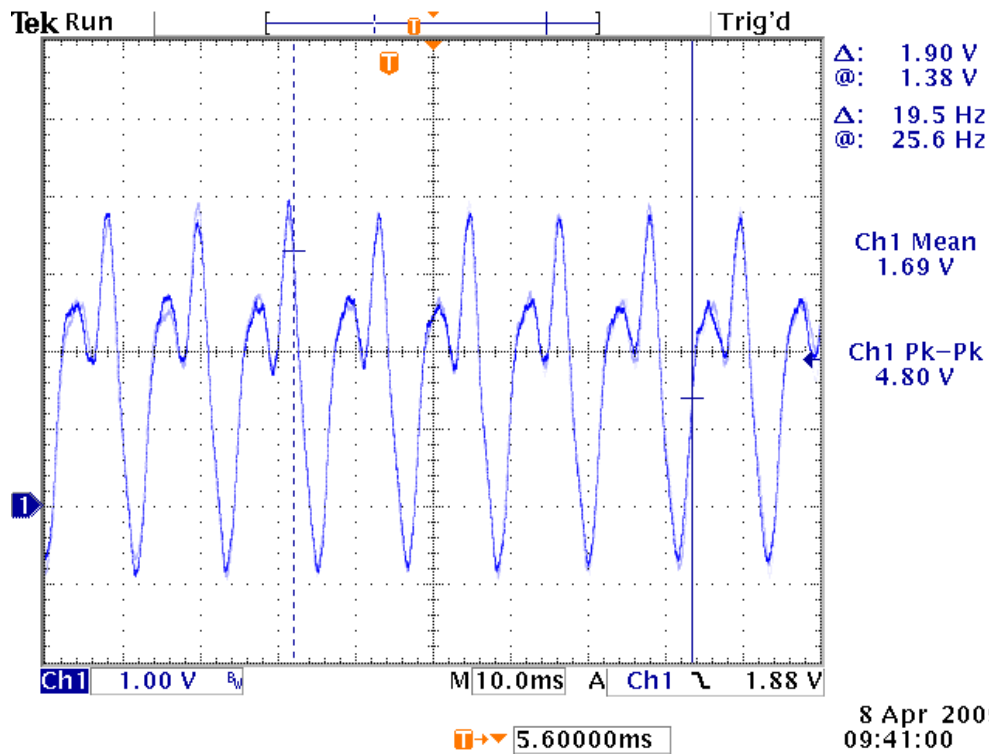
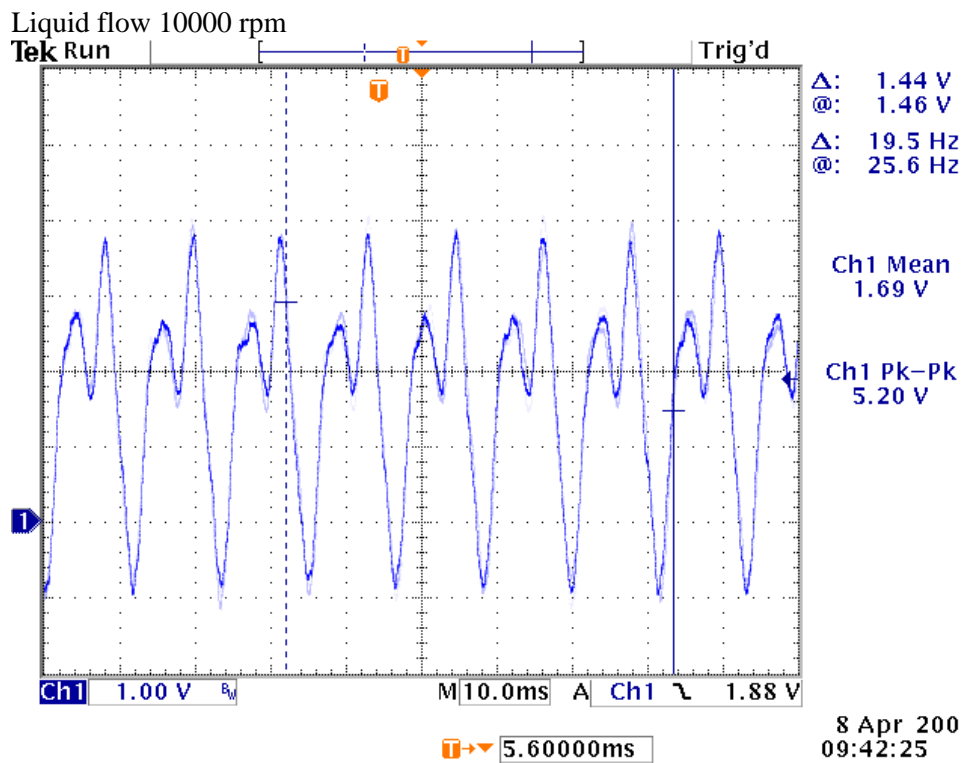
Two-phase upstream coil 10000 rpm
